**Centennial Glen HOA  
7245 Centennial Glen Dr.  
Colorado Springs, CO 80919**

**Level 1, Limited Reserve Analysis  
Report Period – 01/01/16 – 12/31/16**

**Client Reference Number - 9162  
Property Type – Single Family Development  
Number of Units – 46  
Fiscal Year End – December 31**

**Date of Property Observation - October 20, 2015  
Project Manager - G. Michael Kelsen, RS, PRA  
Main Contact Person - Mr. Lynn Dougherty, Board Member  
Report was prepared on - Thursday, February 04, 2016**

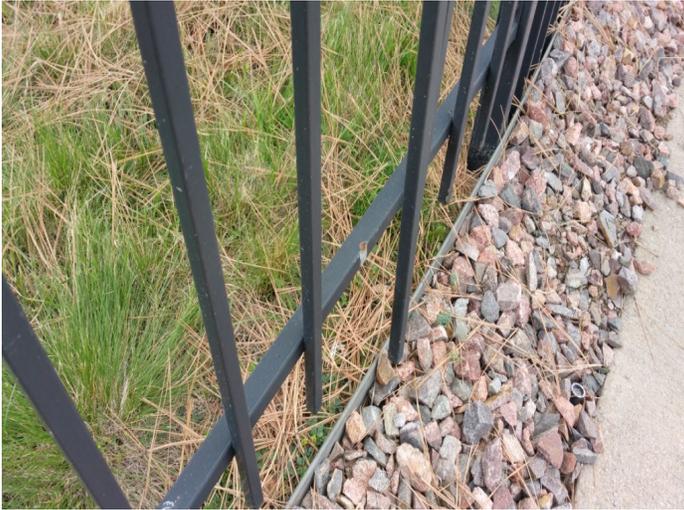
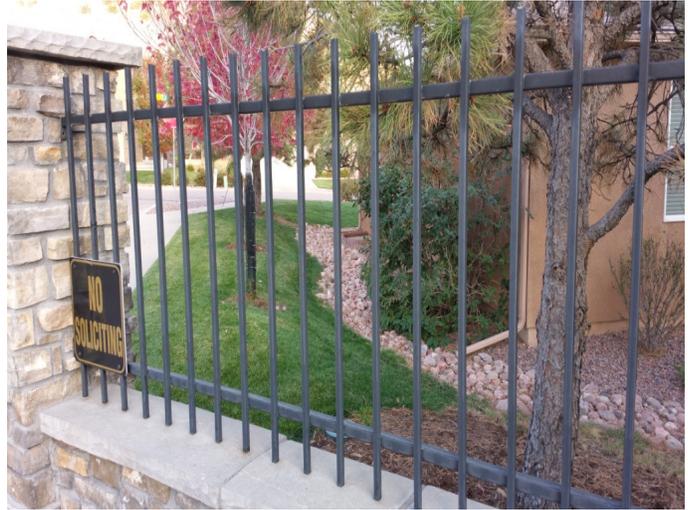
Comp #: 207 Iron Fencing - Repaint

- This type of fence should be repainted every 3 - 4 years to protect the metal from rusting and corrosion.
- In order to achieve a full life expectancy, proper prep work, such as scraping loose paint and removing any rust and corrosion, should be performed before each painting cycle.

*Location:* **Along Centennial**

*Life Expectancy:* **4** Remaining Life: **0**

*Best Cost:* **\$14,750**

\$7.00/LF; Estimate to repaint fence

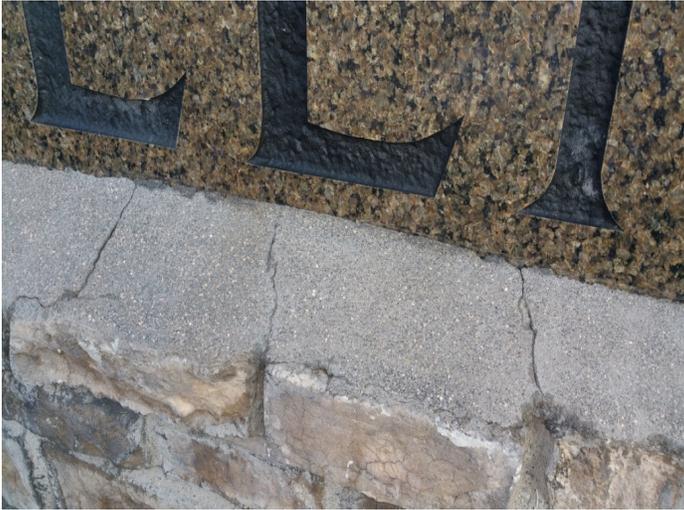
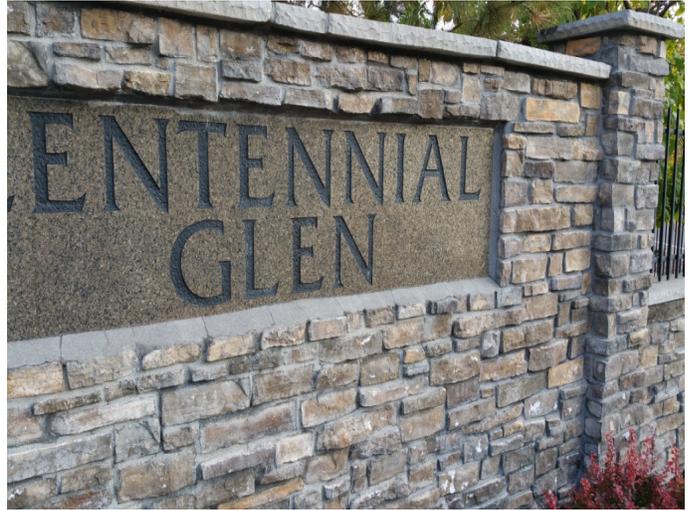
Comp #: 801 Monument - Major Refurbishment

- The monument structure appeared in good condition at time of observation with no noticeable damage to materials.
- It is unlikely that the monument will require complete replacement or rebuilding due to the materials failing, however, due to changes in decorative tastes, we recommend reserving to update the monument every 20 - 25 years to ensure an appropriate and attractive appearance to the community entrance.

*Location:* **Allegheny and Centennial intersection**

*Life Expectancy:* **25** Remaining Life: **12**

*Best Cost:* **\$30,000**

\$15000/monument; Allowance for major repairs

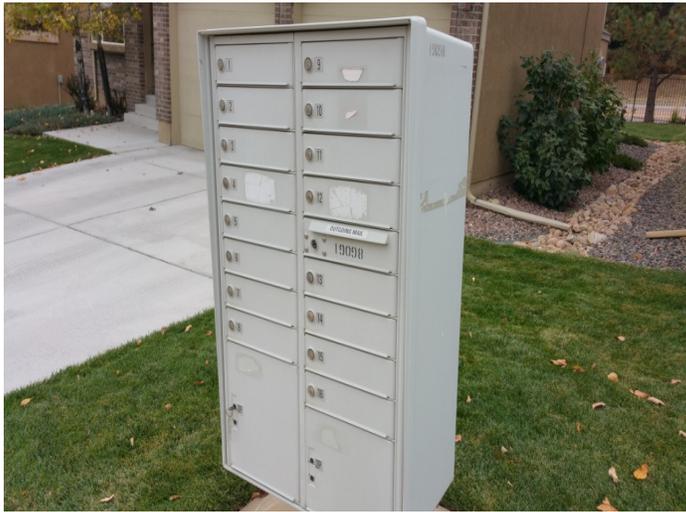
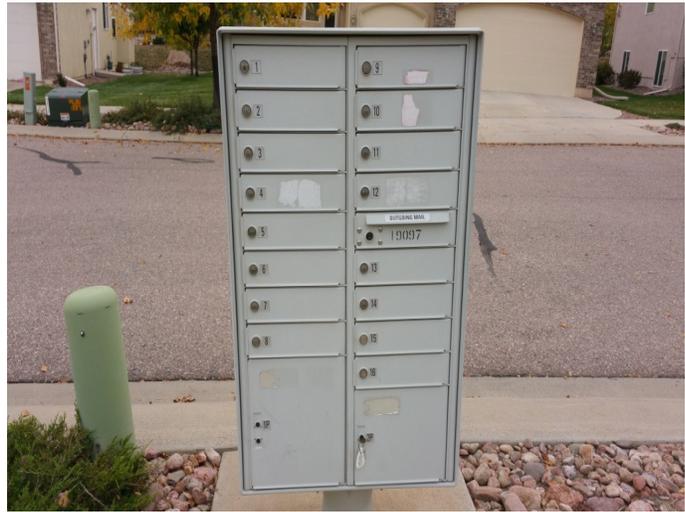
Comp #: 803 Mailboxes - Replace

- This line item is for the original mailboxes that were installed when construction of the community began.
- While it is possible the USPS will maintain these boxes, we are starting to see the responsibility of all mailboxes get turned over to associations.
- Therefore, funding should be included for conservative measures.
- Based on our experience, these boxes will have a life expectancy of 15 - 20 years due to location and quality.
- Remaining life is based on age and observed condition.

**Location:** Adjacent to streets

**Life Expectancy:** 20 Remaining Life: 7

**Best Cost:** \$4,950

\$1650/CBU; Estimate to replace

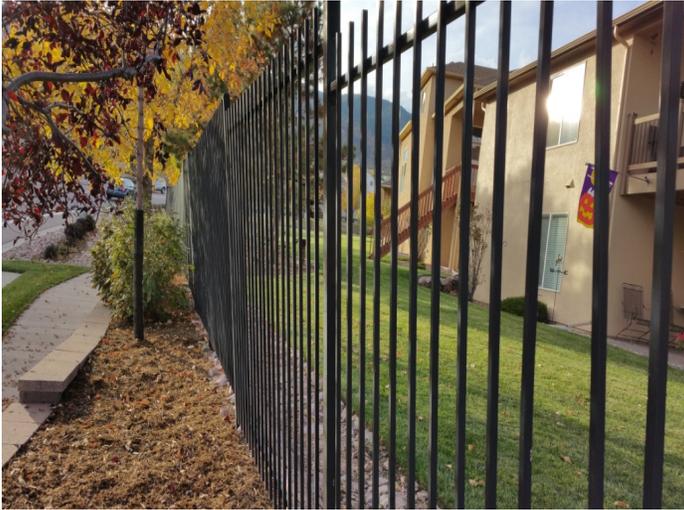
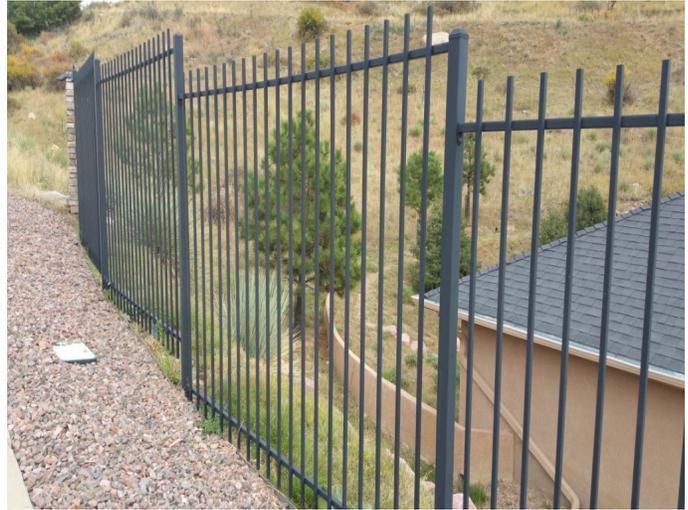
Comp #: 1002 Ironwork Fencing - Replace

- Approximately 125 LF of fence is leaning at about the mid point of the fence line between Centennial Glen entrance and Allegheny entrance.
- The average life expectancy for metal fences ranges between 25 - 30 years, depending on maintenance schedules and exposure to elements.
- The remaining life is based on age of fence and observed conditions.

*Location:* **Along Centennial**

*Life Expectancy:* **28** *Remaining Life:* **16**

*Best Cost:* **\$94,725**  
\$45/LF; Estimate to replace

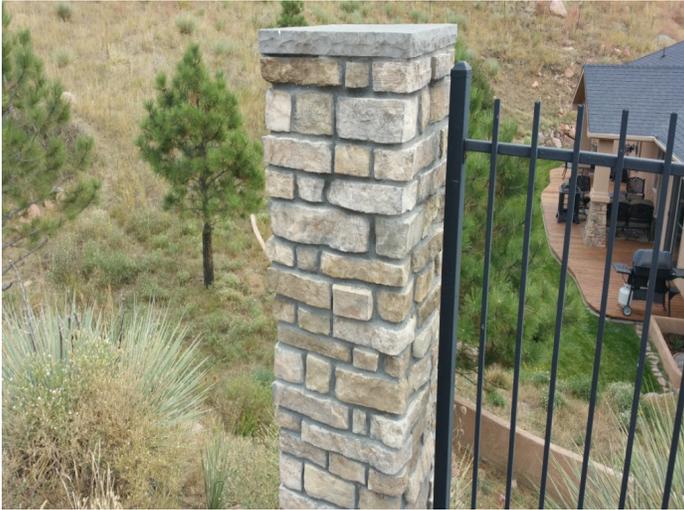
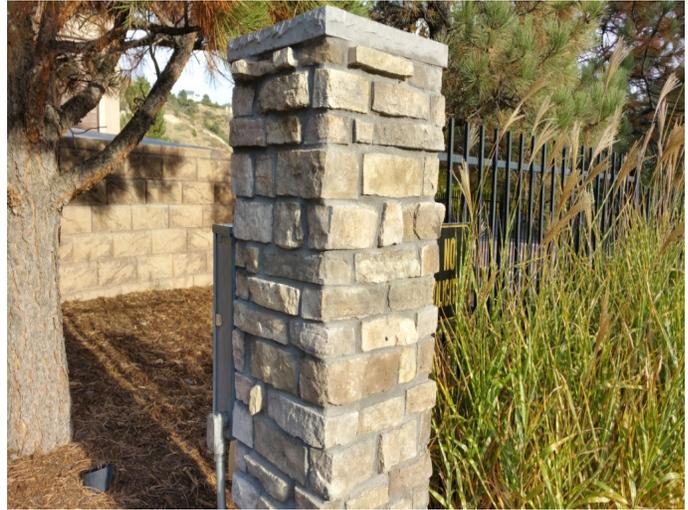
Comp #: 1005 Stone Columns - Major Repairs

- While it is unlikely that the entire column will need to be replaced, it is possible that major repairs will be necessary to replace loose or missing stones.
- Depending on the effects from weather and other elements, we suggest establishing a Reserve fund for periodic repairs to the pillars every 15 - 20 years.

*Location:* **Along Centennial Blvd.**

*Life Expectancy:* **16** Remaining Life: **8**

*Best Cost:* **\$1,800**

\$300/column; Allowance for major repairs

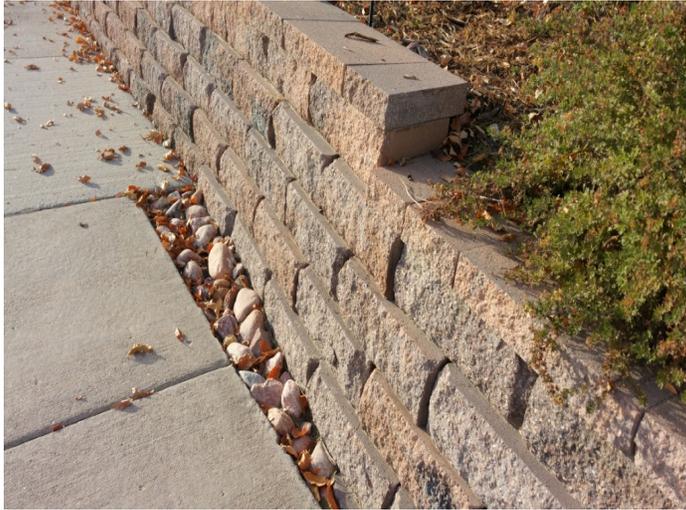
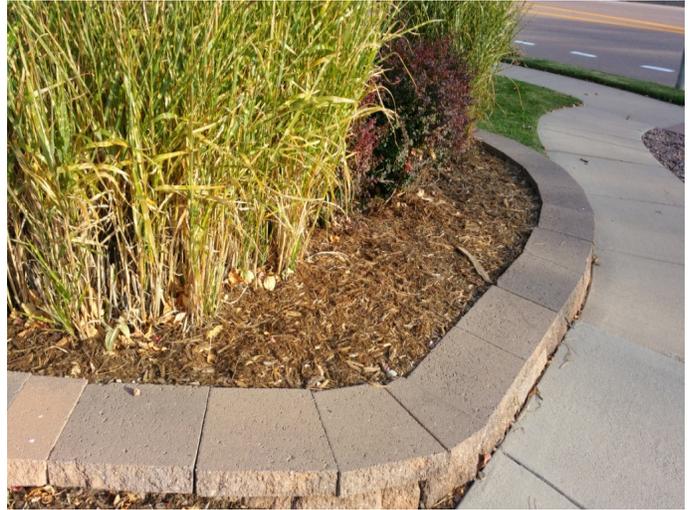
Comp #: 1011 Retaining/Block Wall - Major Repairs

- As long as block wall was installed conforming to county code requirements, this wall should have an extended useful life.
- This type of material has an indefinite life expectancy and complete replacement is unlikely.
- Therefore, Reserve funding is not required for this component at this time.

*Quantity:* **Approx. 2080 GSF**

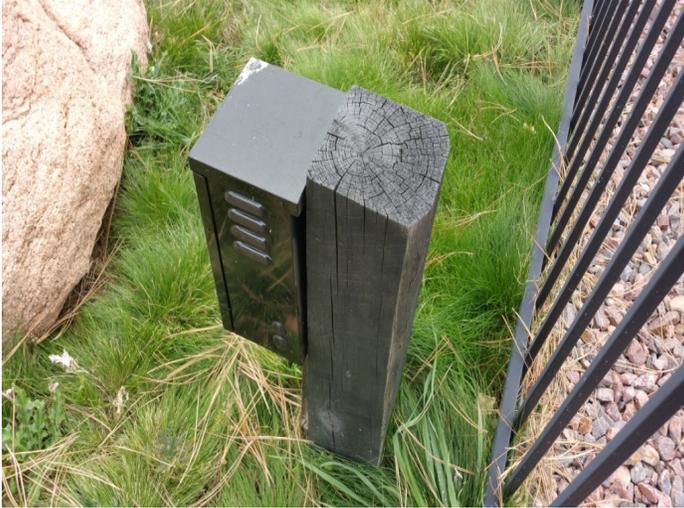
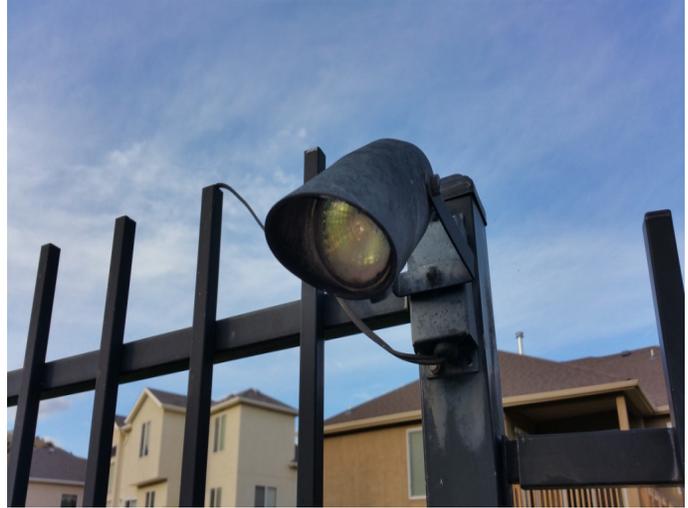
Comp #: 1603 Landscape Lights - Replace

- Because these lights are consistent in appearance and clearly visible to the general public, we recommend replacing all at the same time.
- In this climate, we see the need to replace these lights every 10 - 15 years on average under normal conditions.
- Current lights do not appear to be original to the beginning dates of construction.

*Location:* **Tree lighting**

*Life Expectancy:* **12** Remaining Life: **7**

*Best Cost:* **\$2,750**

Estimate to replace with similar

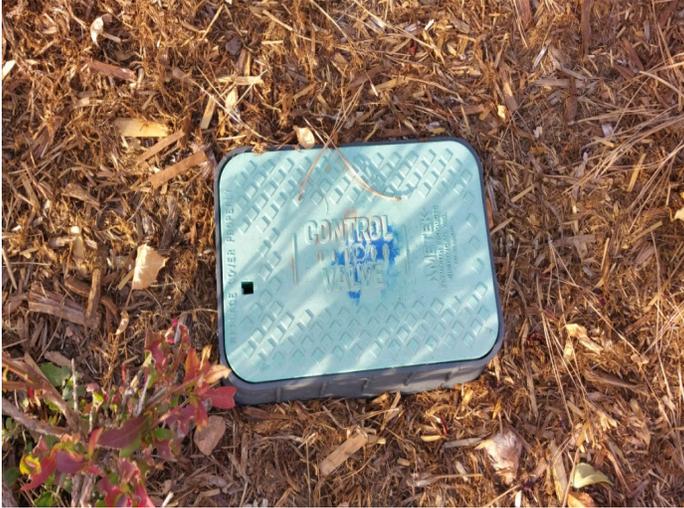
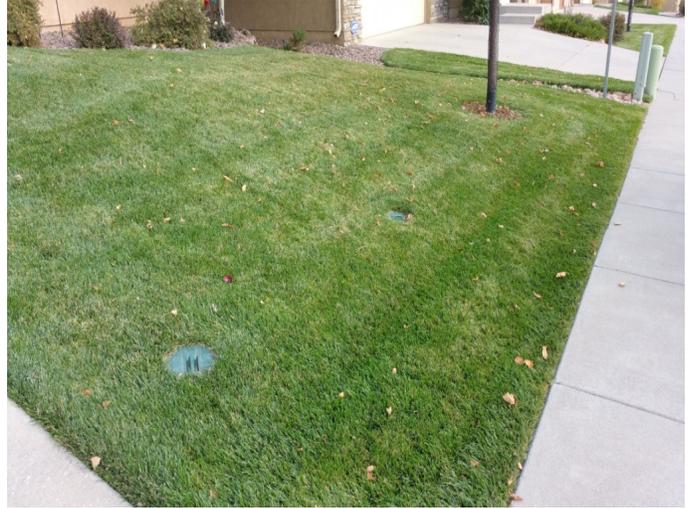
Comp #: 1701 Irrigation System - Rebuild

- At the time of the site evaluation, we observed what appeared to be a leak in the sprinkler valve box by unit 7205. We reported this to the board member and it was mentioned the landscaper would be called.
- The materials used during construction should have a long life expectancy with proper maintenance.
- At this time, there is no expectancy to completely replace the system and Reserve funding is not recommended.
- We recommend the association establish a line item in the general operating budget for annual repairs to necessary components of the system (broken lines, sprinkler heads, valves, backflow preventers, etc).

***depends on how installed. 35 - 45 years out there.***

***Will always have components that will fail over time. All installed to be serviceable for the long term. All repairs can be done as needed with operating funds.***

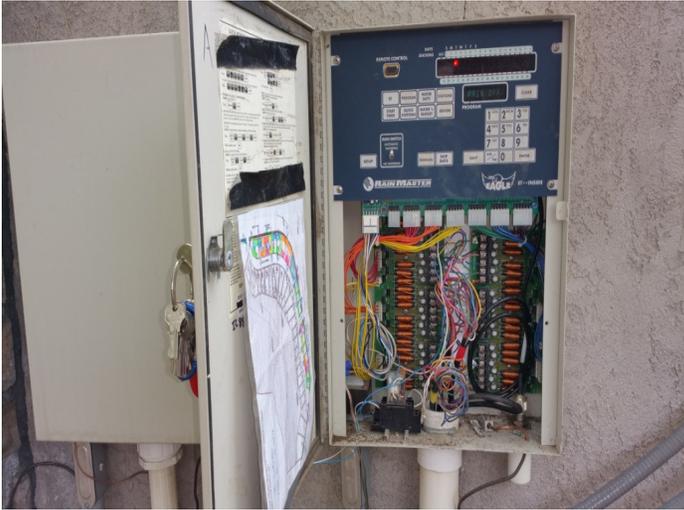
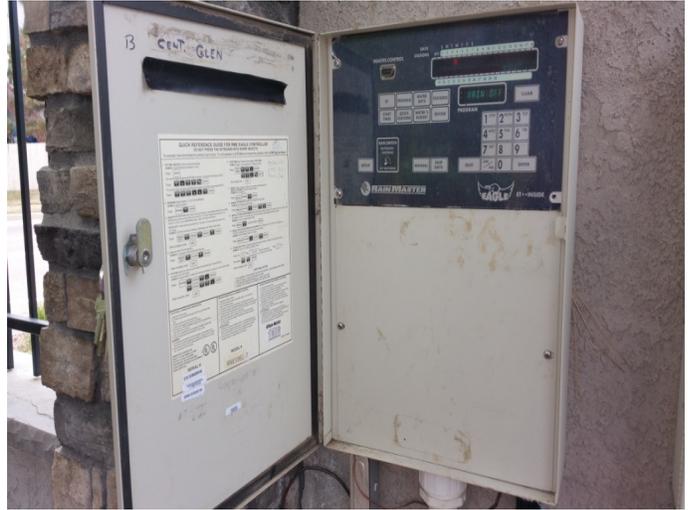
Comp #: 1703 Irrigation Controllers - Replace

- Expect to replace irrigation controllers every 10 - 15 years if properly maintained and under normal conditions.
- Funding is for replacement with similar controllers as these are more efficient and can be controlled remotely by landscaping experts, saving the association irrigation water costs.

**Location:** Behind north monument

**Life Expectancy:** 15 Remaining Life: 5

**Eagle ET, 36 stations  
model #RME30EGIT  
serial #EG9608048 and unknown**

**Best Cost:** \$8,000  
\$4000/controller; Estimate to replace

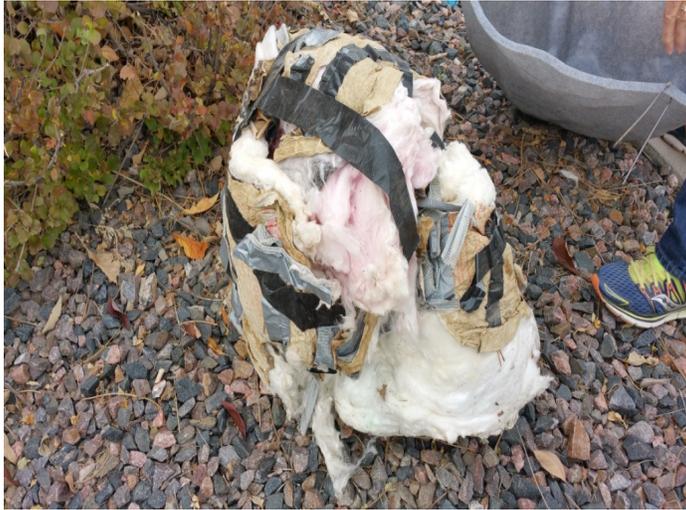
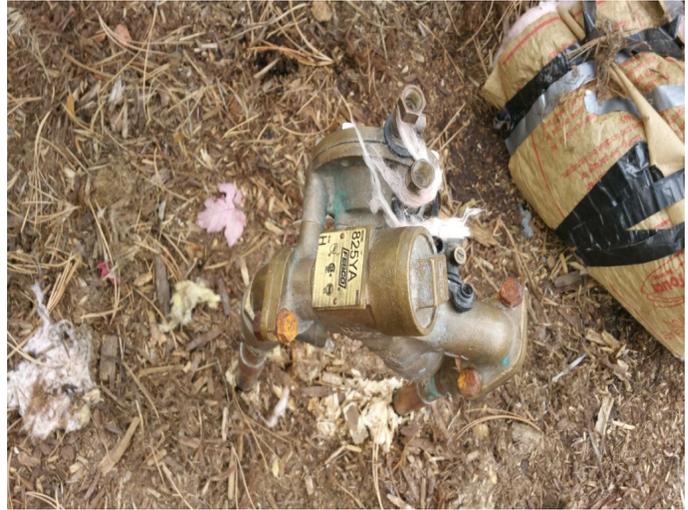
Comp #: 1706 Backflow Devices - Replace

- Devices are enclosed in a protective environment to shield from direct exposure to elements. No reported problems with any of the devices.
- Due to the ability to rebuild and replace these devices for a relatively low cost and the fact that failure of the device is unpredictable, we do not recommend reserving for replacement.
- Repair and/or replace these devices/enclosures on an as needed basis using operating funds.

*Location:* **Unit 7446 & 7376**

*Quantity:* **(2) Febco devices**

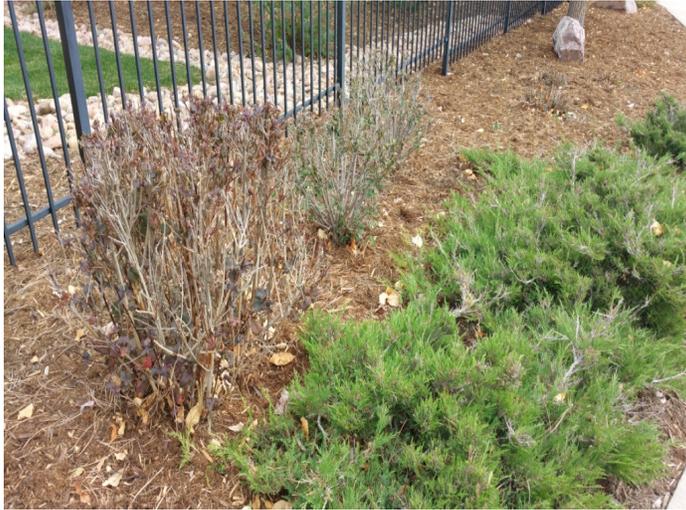
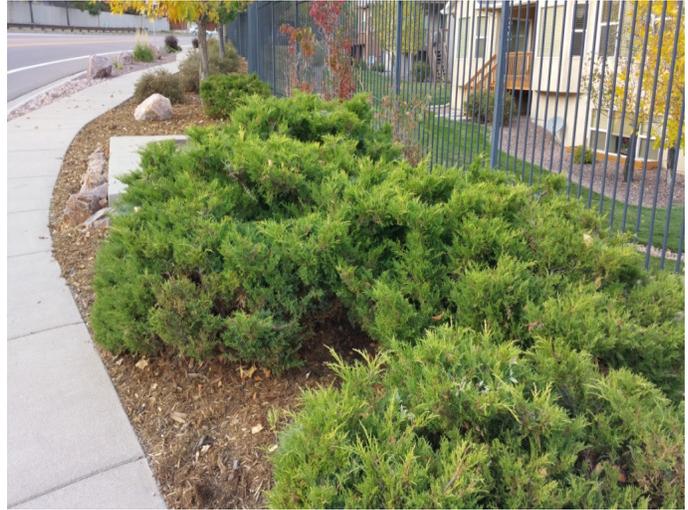
Comp #: 1801 Groundcover - Replenish

- Typically, associations will establish a line item in the operating budget to handle annual replacement of shrubs, plants, grass areas, etc.
- Therefore, separate Reserve funding is not necessary as long as funding has been established in a separate budget.
- If the association prefers to include a funding allowance for groundcover replenishment, then we would need to know how much and how often the current board of directors would prefer to set aside since this would be considered a discretionary expense.

*Location:* **Along Centennial Blvd.**

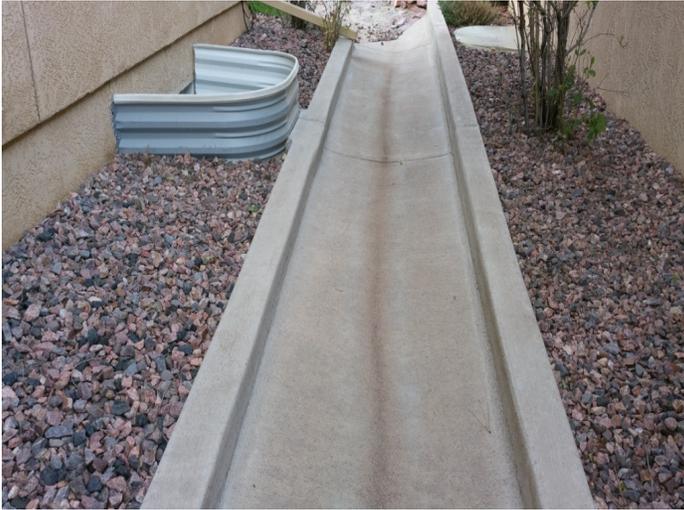
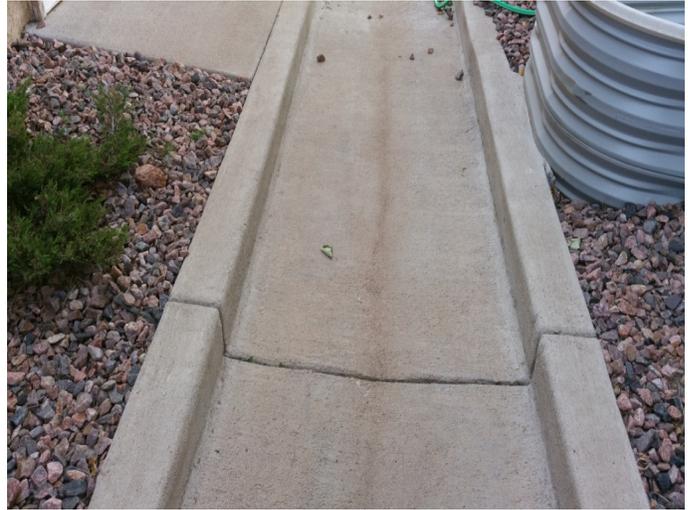
Comp #: 1811 Landscape Drain Pans - Repair

- It was reported that this area of drain pans is not the responsibility of the association.
- Therefore, separate Reserve funding is not required at this time.

*Location:* **Between 7285 & 7305**
